## Research Topic 1: Site Selection Layout and Drainage

## Research Topic 5: Management Erosion and Sedimentation

Research Site/Demonstration Number: SA01WB-02 and SA05WB-02

Grower Collaborator: Littabella Pines

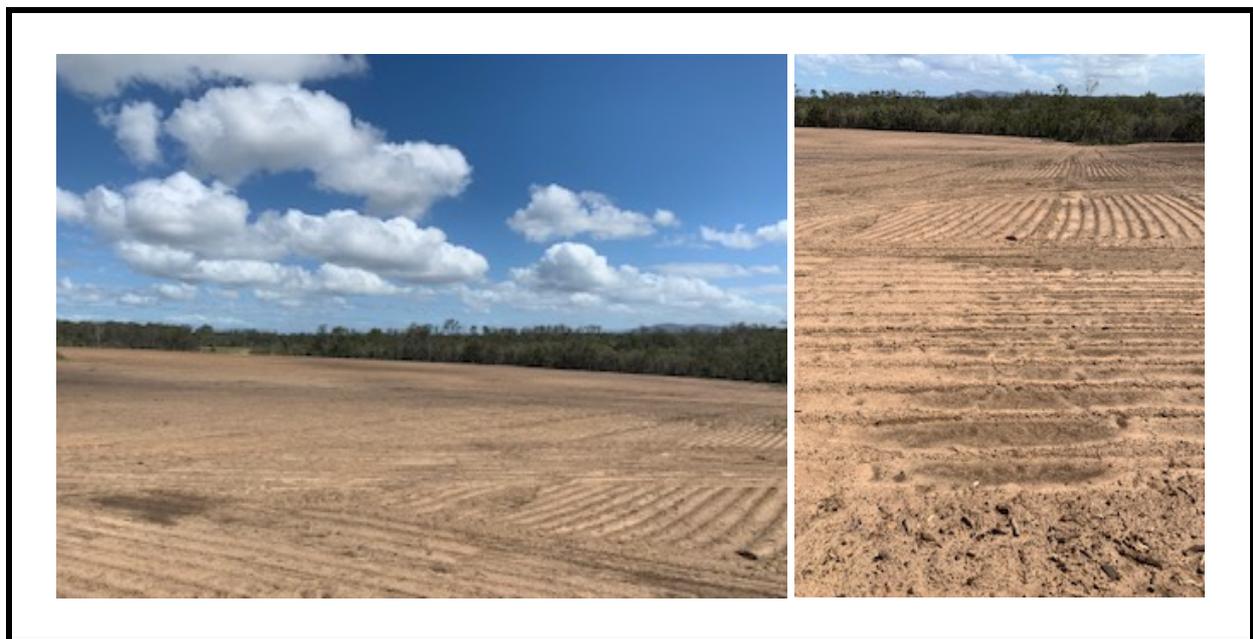
Trial site - prior to treatments

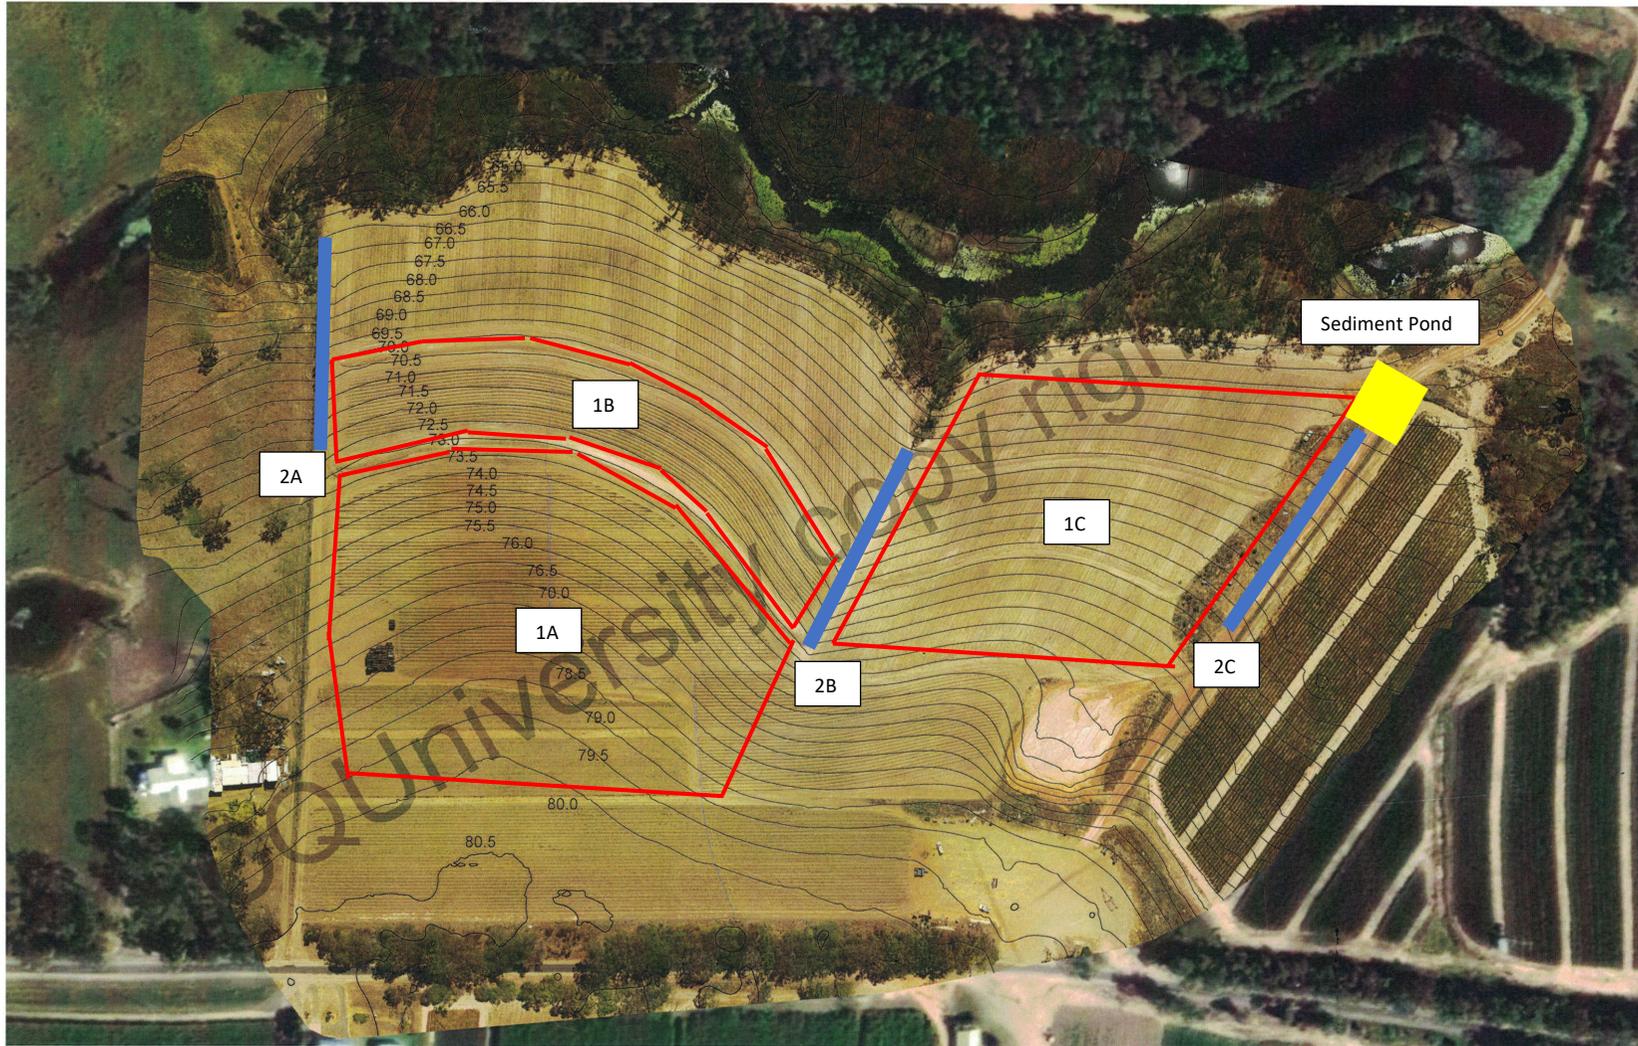
Contour map of trial location (image courtesy of Central Queensland University).

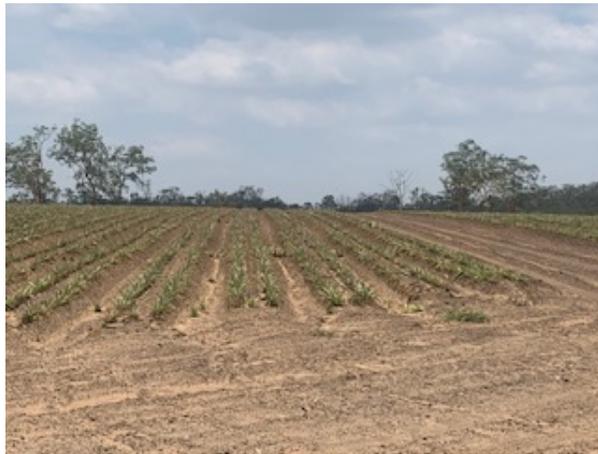
Treatment 1A - beds planted up and over slopes with no contour banks (standard practice),

Treatment 1A (standard)

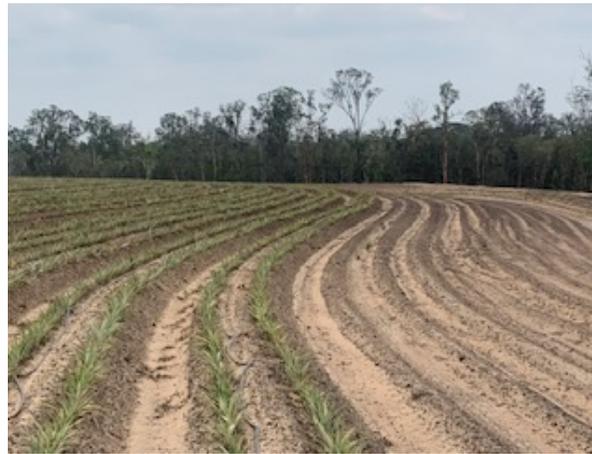
Treatment 1B– beds planted to contours on 1-2% slope, and

Treatment 1B

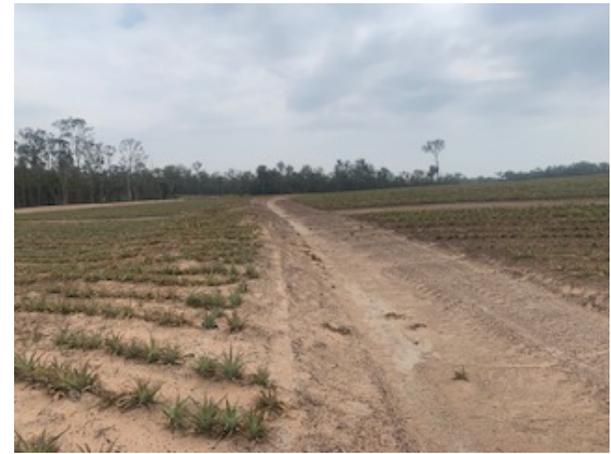
Treatment 1C – beds planted down slope separated by contour drains / banks on 1-2% slope.

Treatment 1C

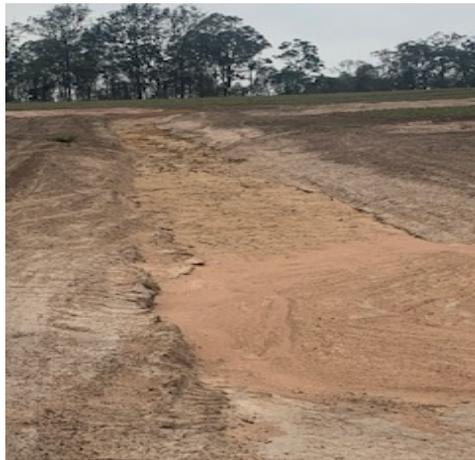
Prior to installation

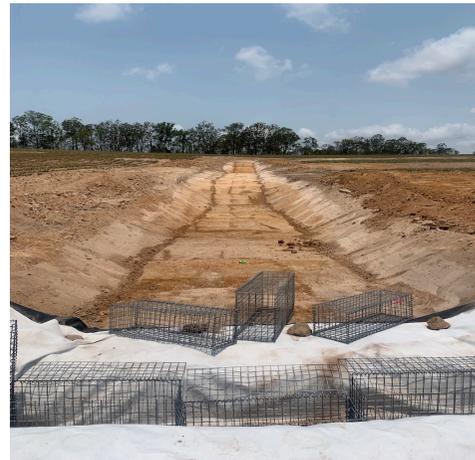
Completed earthworks of drain

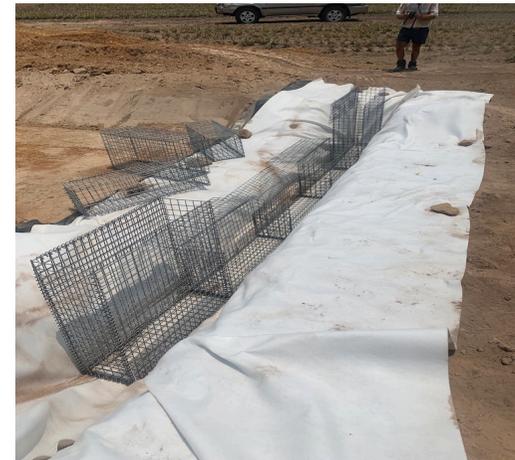
Gabian basket levy bank

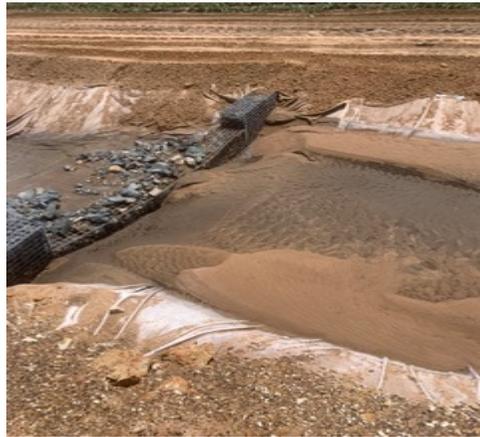
Eroded soil after first rainfall event

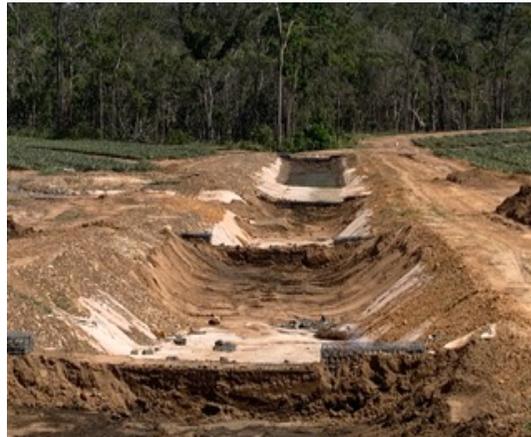
Soil after initial clean out

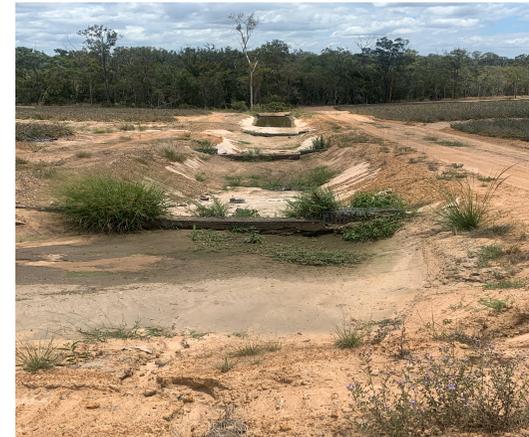
Covered drain at 12 months

Treatment 2B consisted an open drain stabilised by Geofabric, segregated by gabian basket levy banks with a silt trap located at the bottom. The catchment area emptying into this drain is from beds planted up and over slopes with no contour banks (standard practice). Within this treatment a high level of erosion from the catchment area has been contained within the drain. The containment of the sediment has primarily occurred above each of the gabian basket levy banks.

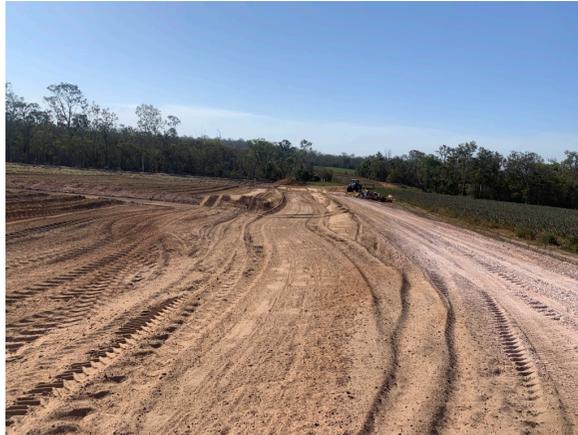
Prior to installation

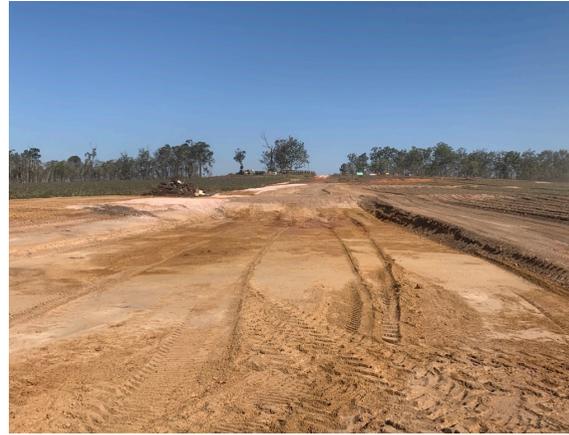
Completed earthworks of drain

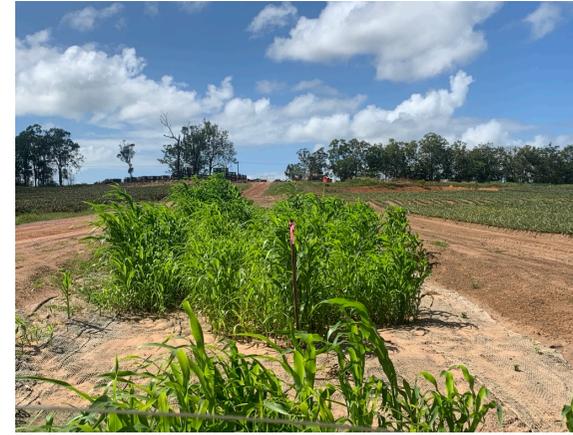
Dute Mesh and cropped with sorghum

Treatment 2C consisted an open drain stabilised by Dute Mesh as a ground cover then planted with a vegetative crop of sorghum. The drain then emptied into a sediment pond at the bottom. The catchment area emptying into this drain consisted beds planted down the hill separated by contour drains. Within this treatment moderate levels of sediment were captured in the drain, however a good volume of sediment over-flowed into the sediment pond.

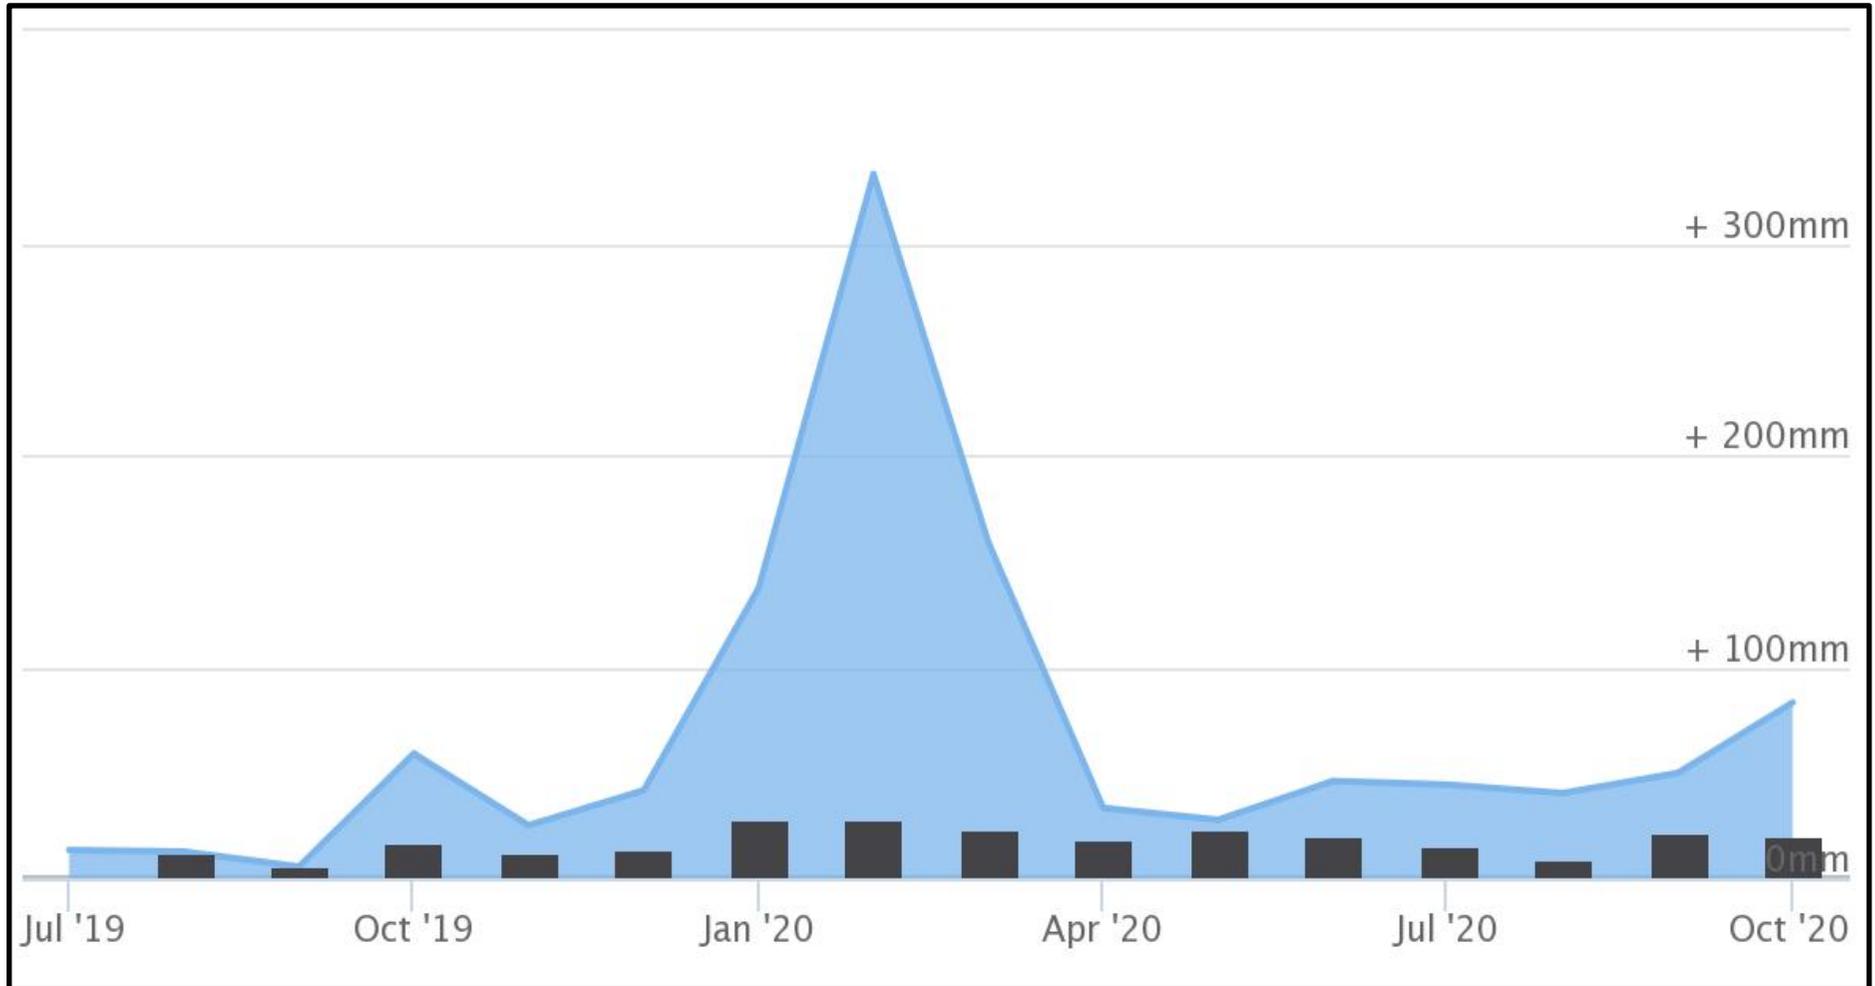
Yandaran Rainfall Data

Soil erosion levels were measured using metal troughs buried at the edge of the pineapple fields in each treatment. Two metres of plastic sheeting were laid on the surface of the ground and seed beds leading into the troughs. The plastic sheeting allowed unobstructed flow of water and sediment directly into the troughs. The troughs captured water at each rainfall event and once the water had evaporated the sediment remained in the trough. From the period of April 2019 to November 2019 there were no rainfall events. However, from late December 2019 to April 2020 a significant number of rainfall events occurred throughout this period. The next 6 months there was little rainfall and no major rainfall events until October 2020.

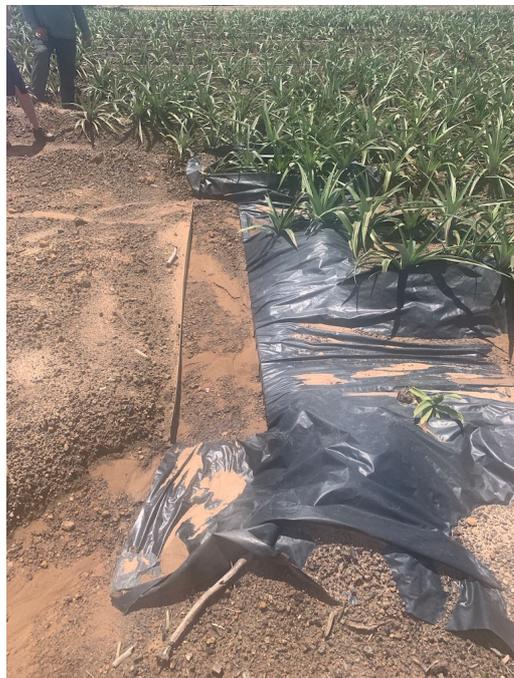
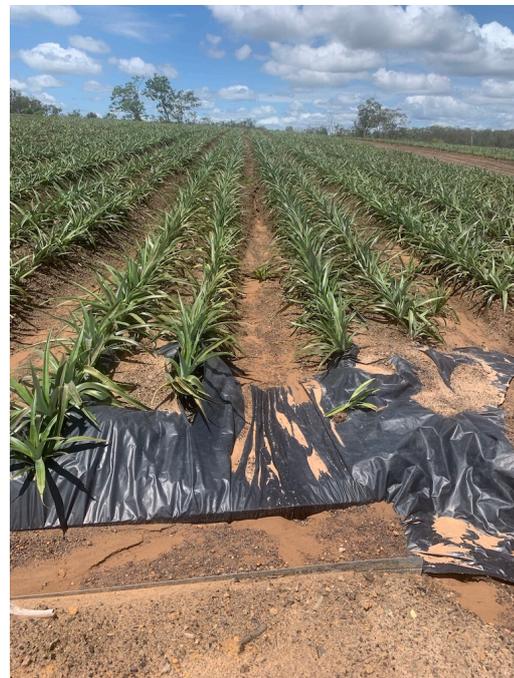
Treatment 1A - initial rainfall event with high amounts of sediment.

- Significantly high amount of soil erosion in the standard practices, lowest soil erosion in pineapples planted along the 1% contour and moderate to high levels soil erosion in the treatment with pineapples planted down slope separated by contour drains / banks.
- Both standard and pineapples planted along the 1% contour treatment - soil erosion was captured on the edge of field (outside the block).
- The treatment with pineapples planted down slope separated by contour drains / banks sediment was captured within the block by the contour banks / drains.
- Clear, visible signs of waterlogging were observed in the treatment with pineapples planted along the 1% contour which would lead to issues of phytophthora root rot.

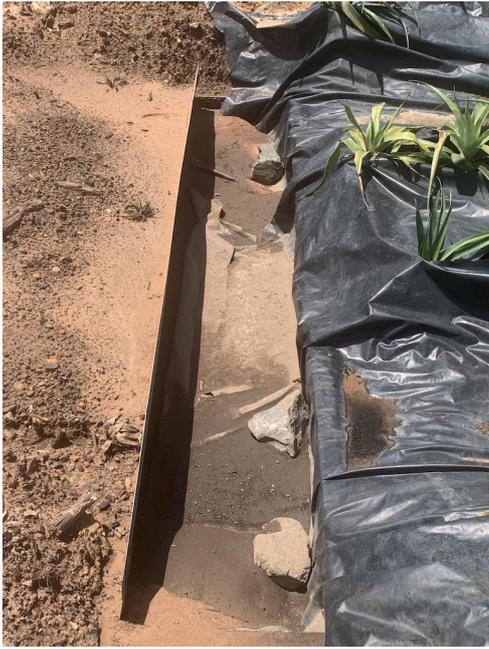
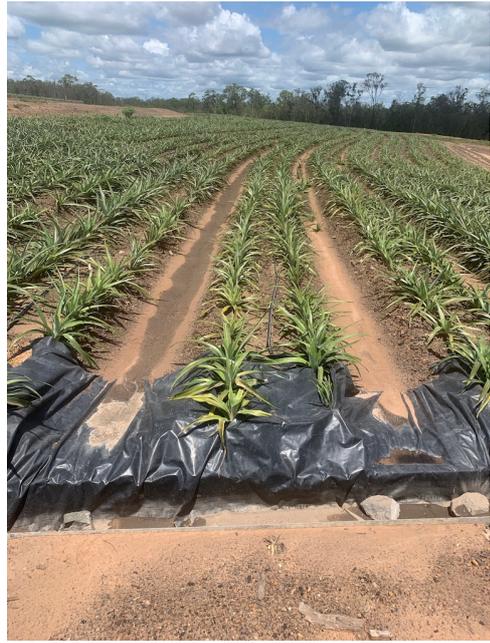
Treatment 1B - low amounts of sediment and water logging in field

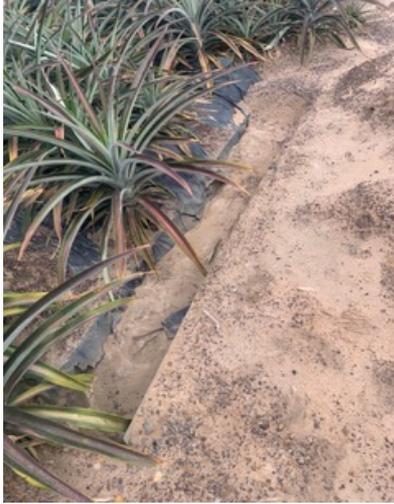
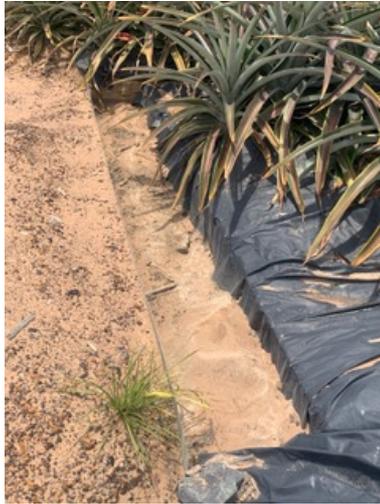
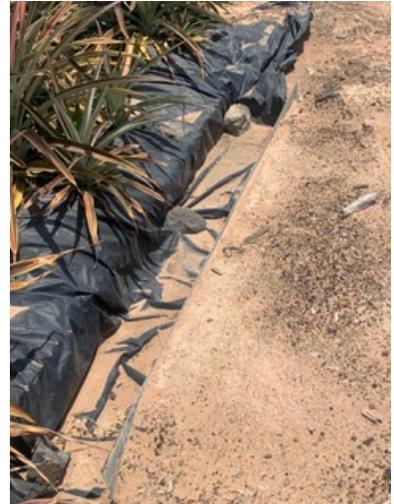
All Treatments – summer to spring 2020 minimal sediment captured

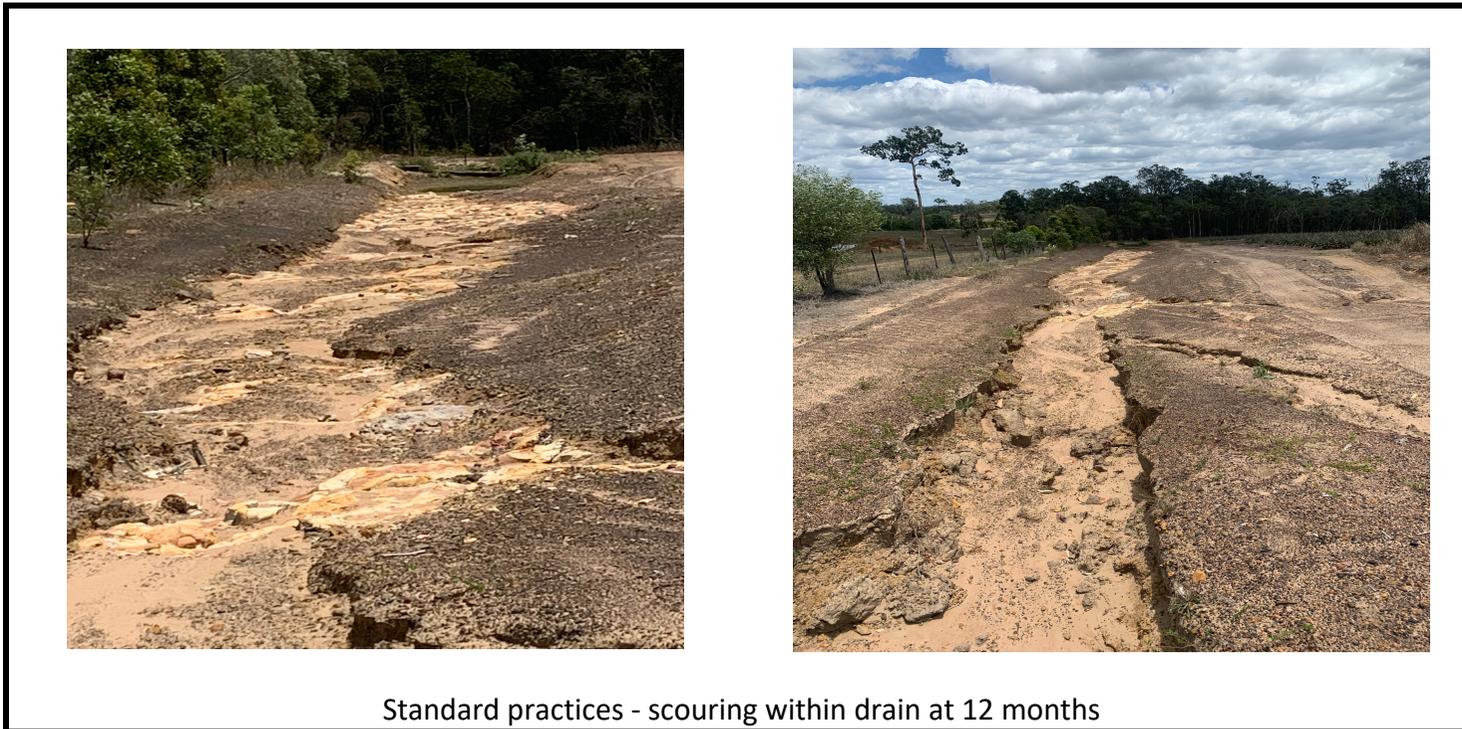
Treatment 2A consisted industry standard practices with no coverage or stabilisation of the drain. Observations over the 12 month period indicated severe scouring has occurred 40 - 60cm down to the hard rock and clay layers within the soil profile. The drain has had no capacity to retain any sediment and will continue to scour further over future rainfall events. A reinforced silt trap at the bottom of the drain was constructed to capture sediment but has not had the capacity to retain all of the erosion coming off the catchment area. High levels of sediment have overflowed the silt trap and left the farm.

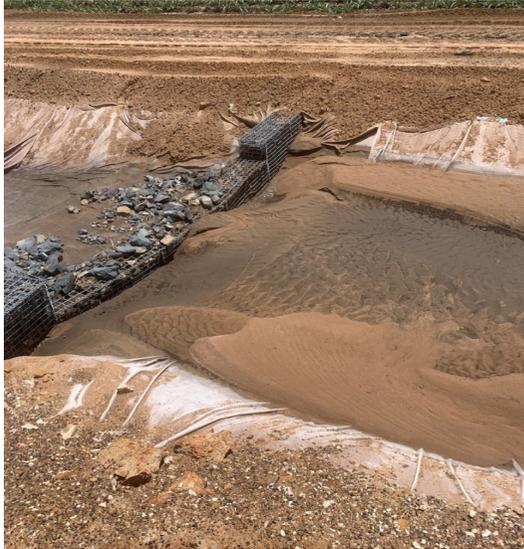
Sediment captured in primary drain

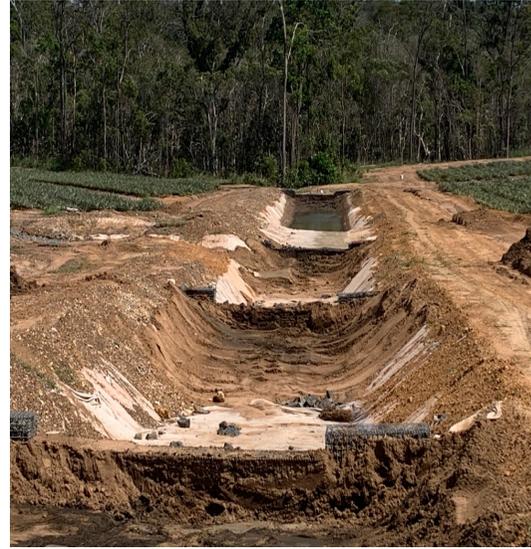
Sediment removed from primary drain

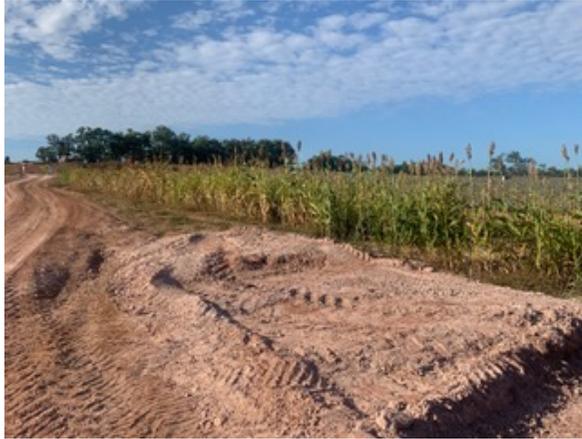
Fully Grown Sorghum

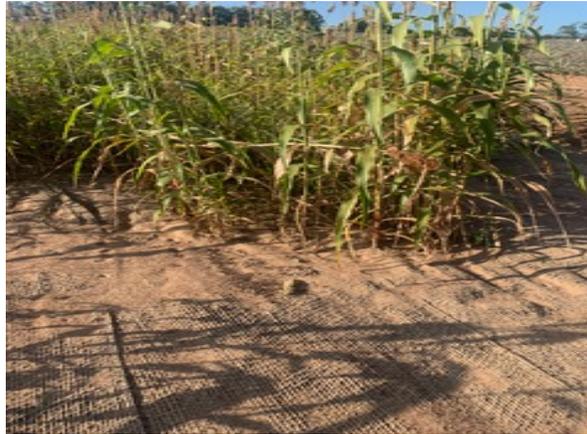
Eroded soil captured on Dute Mesh

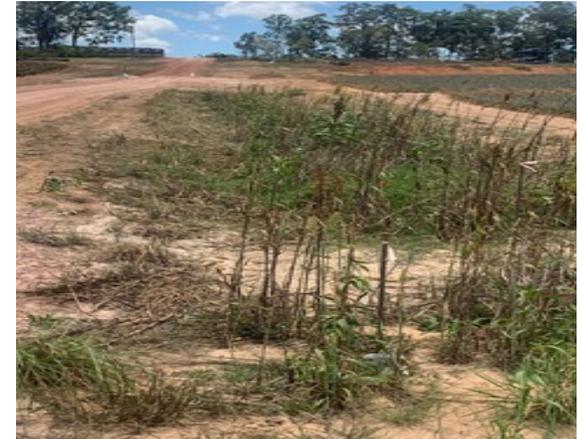
Vegetated drain at 12 months
